# TRUCK ROUTE ACCESS EVALUATION

Norfolk Southern Rail Terminal  
Louisville  
Site # 1767

KTC Report No. 99-33

“Freight Movement and Intermodal Access in Kentucky”  
Project No. SPR 98-189

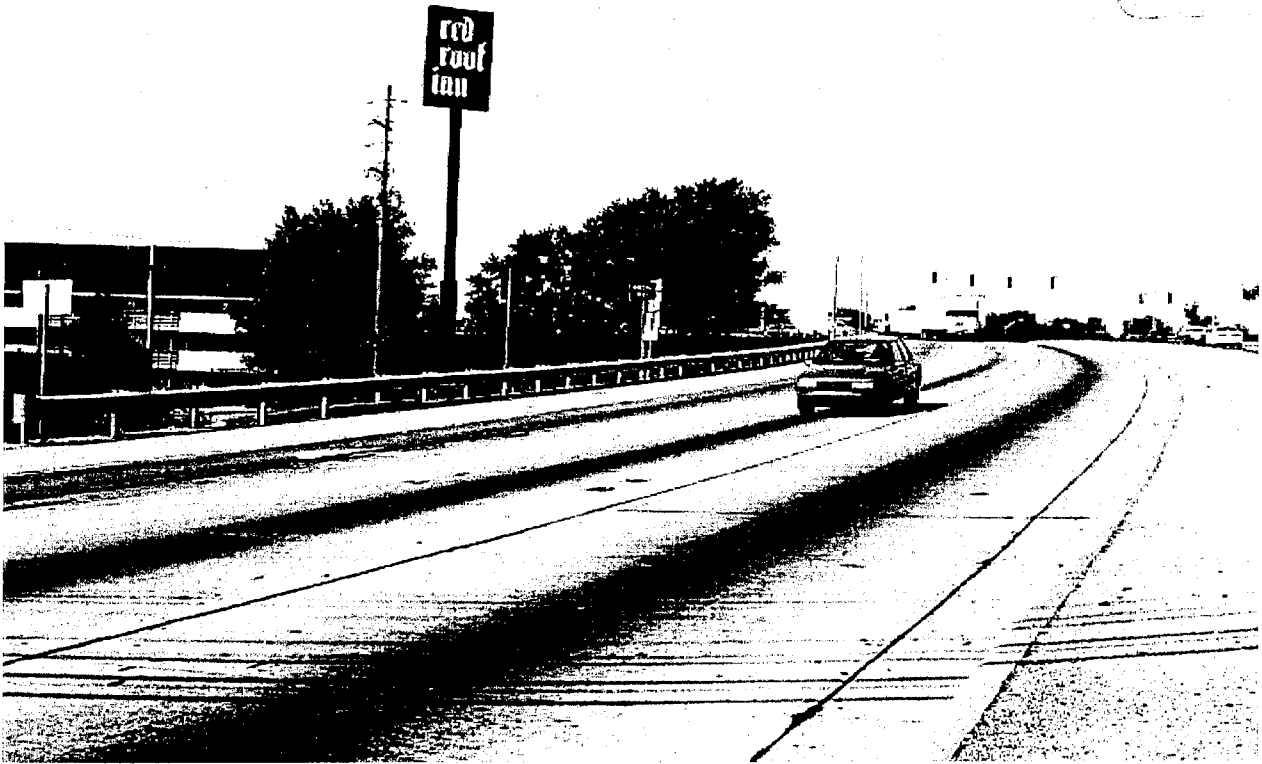
**Figure 5: Newburg Road looking towards I-264 from Bishops Lane**

Grades are considered problematic if they cause trucks to slow down excessively. Using the AASHTO speed reduction tables there are no grades on these routes that cause such speed reductions. However, the upgrade towards the I-264 overpass on Newburg Road as trucks are turning from Bishops Lane is large enough to cause labored accelerations (see Figure 5).

The turning radius at the intersection of the eastbound off ramp from I-264 to Newburg Road requires trucks to offtrack into adjacent lanes as shown in Figure 5. Both 53-foot trailers and smaller trucks were observed offtracking. However, because trucks do not offtrack into opposing traffic lanes this radius is rated “adequate” rather than “less than adequate”. The “drop off” beyond the guardrail to the right of the ramp would preclude curve widening at this location.

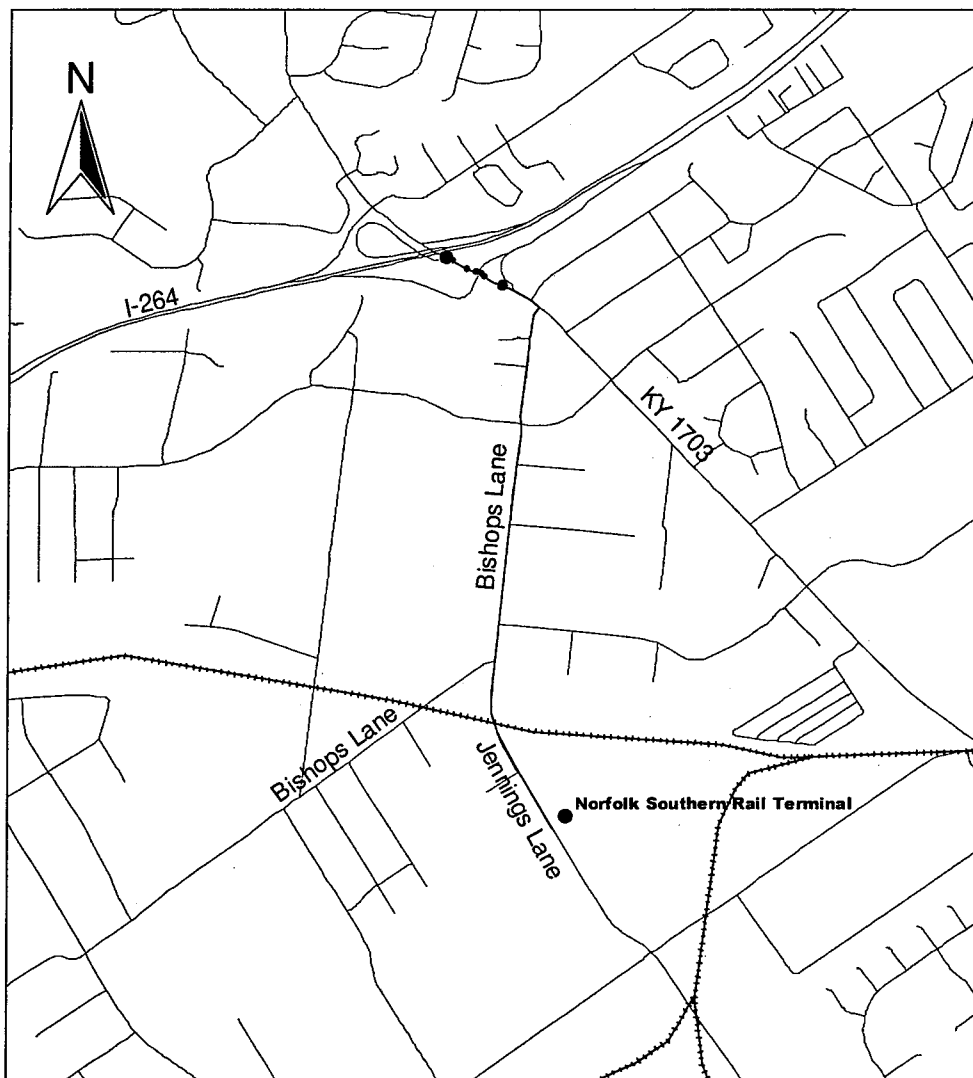
**Figure 6: Accident Locations (1995-1997)**

Figure 6 shows the locations of accidents on the state-maintained sections of the route during the years 1995, 1996 and 1997. The figure shows that a majority of the accidents were at the intersection of the off ramp of I-264 and Newburg Road. This intersection is signalized and has turning radius problems as described later. These results suggest further study at this intersection is warranted.

Although the first two improvements should be undertaken, urban development limits the ability of the state to correct the third and fourth problems. Further investigation of the accident hazard should be seriously considered.

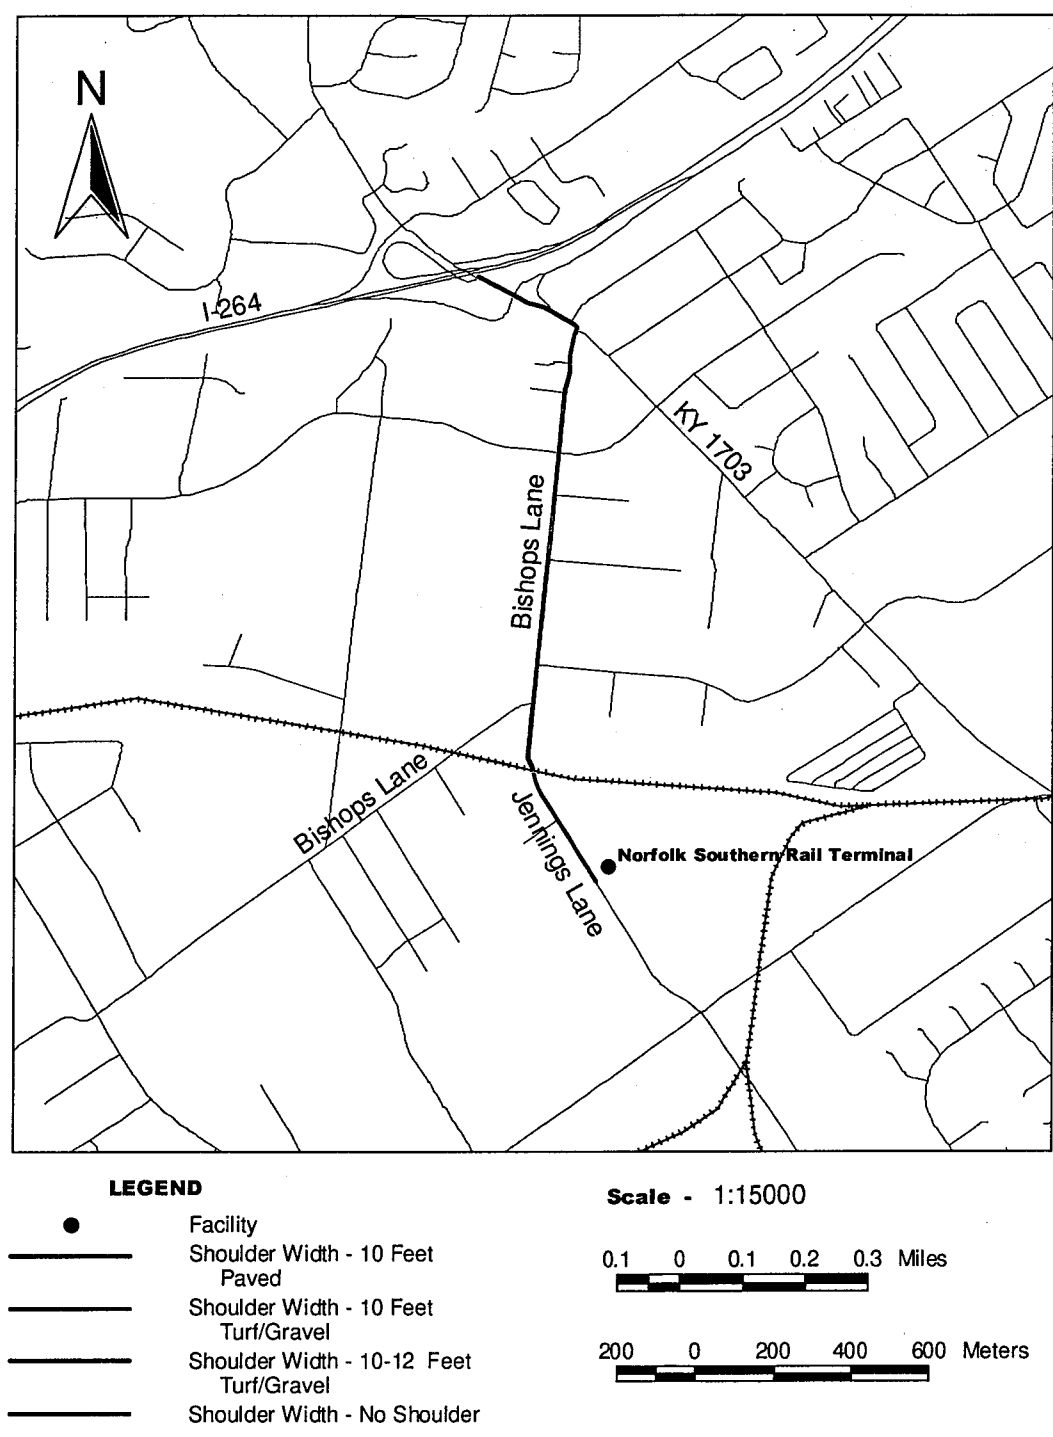
**Figure 7: Shoulder Widths**

All portions of this route have “preferred” 12-foot lanes. Figure 7 illustrates the sections of the routes having different widths and types of shoulders. Bishops Lane has no shoulders and is therefore rated “less than adequate”. This route section is curbed which is typical in urban areas. Clear zone issues might arise from the proximity of sidewalks, utility poles and other activities to this route section (see Figure 3). Jennings Lane has “adequate” 10-foot gravel and/or turf shoulders. As evident in Figure 4 there are no clear zone problems on Jennings Lane. Newburg Road has “preferred” paved 10-foot shoulders. Guardrails provide clear zone accommodations along Newburg Road.

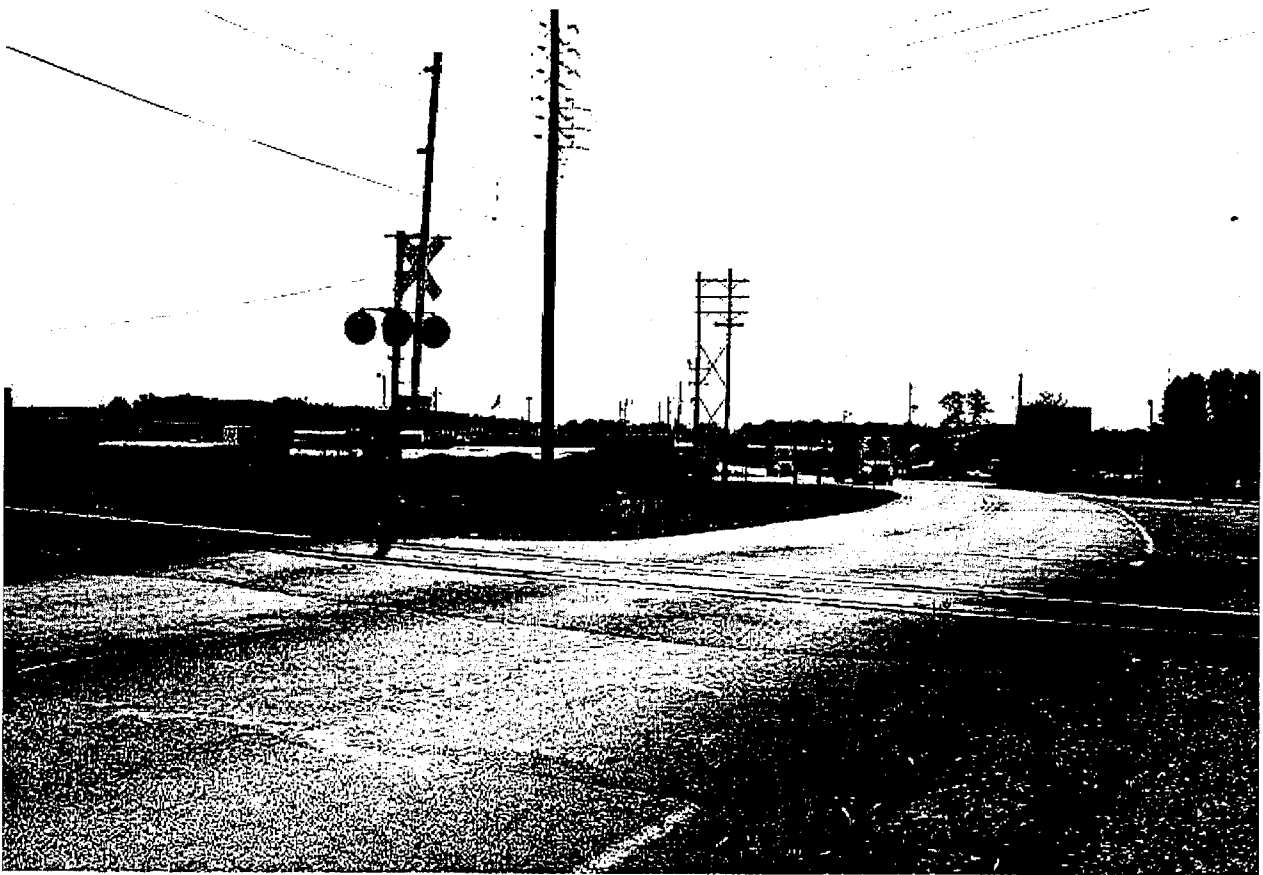
**Figure 8: Railroad Crossing on Jennings Lane**

There is one at-grade railroad crossing on this route located just before the facility on Jennings Lane (see Figure 1). Figure 8 illustrates the crossing looking toward the Norfolk Southern Rail Terminal. The crossing has warning signs, rough road signs, warning lights and gates. Sight distance is good. The crossing had recently been improved with coarse aggregate and asphalt. The pavement surface was good and the crossing was relatively level. This crossing is rated “preferred”.

Residential land use along Bishops Lane, particularly a retirement home, make the appropriateness of this route for heavy truck traffic questionable. There are no accommodations for pedestrians at the railway crossing.
